Characterization of Dust and Weathering Products from the Karabash Smelter area, Ural Mountains, Russia

J. Hechler^{1,3}, V. Udachin⁵, P. Aminov⁵, P.J. Beckett⁴, G.A. Spiers^{2,3,4}

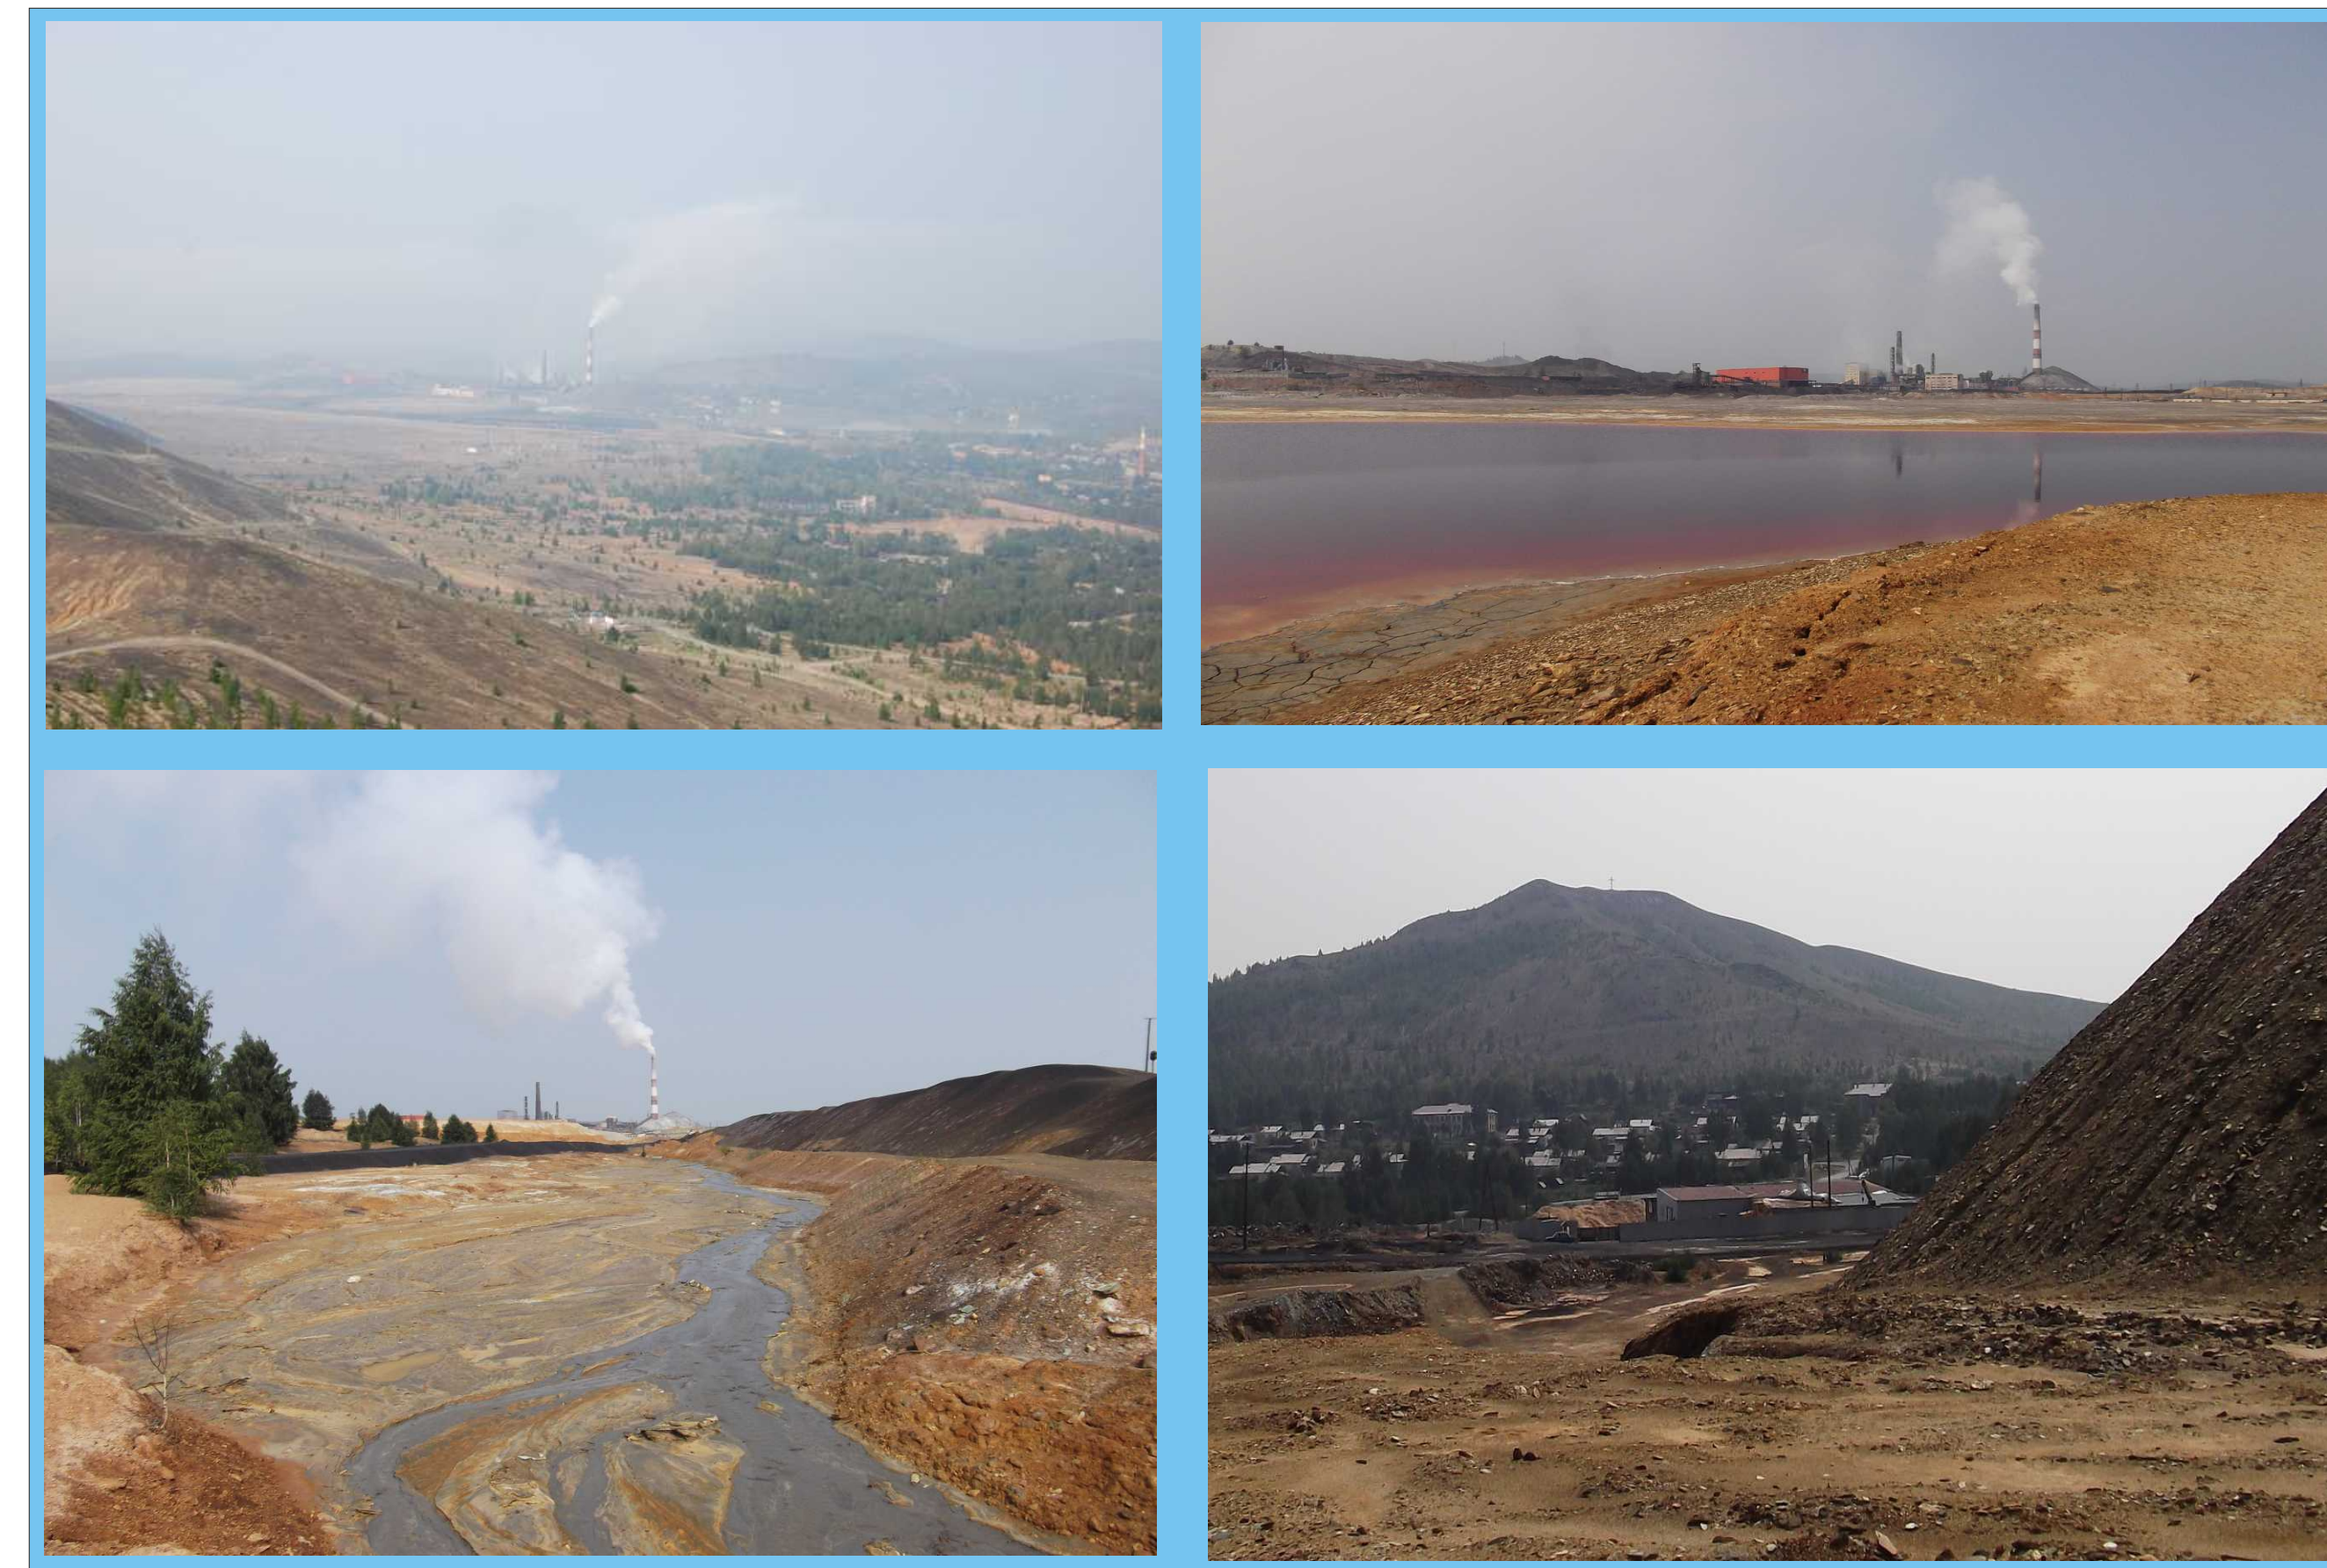
Karabash Smelter Impacted Landscapes

Karabash is a copper smelting town in the Chelyabinsk District of the southern Ural Mountains of Russia. The town and surrounding areas are affected by sulphur dioxide emissions, deposition of metal-rich particulates from the smelter, acid drainage from old mine workings, and leachates from waste dumps and tailings dams.

- The Karabash area, downstream from the smelting operations, has been heavily impacted by fugitive tailings discharge, leading to vegetation kill on the flood plain.
- Subaerial weathering of the tailings is producing obvious signs of acid mine drainage.
- The mineralogy of the smelter deposited dusts consists primarily of zincite and anglesite.
- The salt efflorescence crystals on the tailings-dominated outwash are a mixture of hydrated ferro-aluminous-magnesium sulphates.

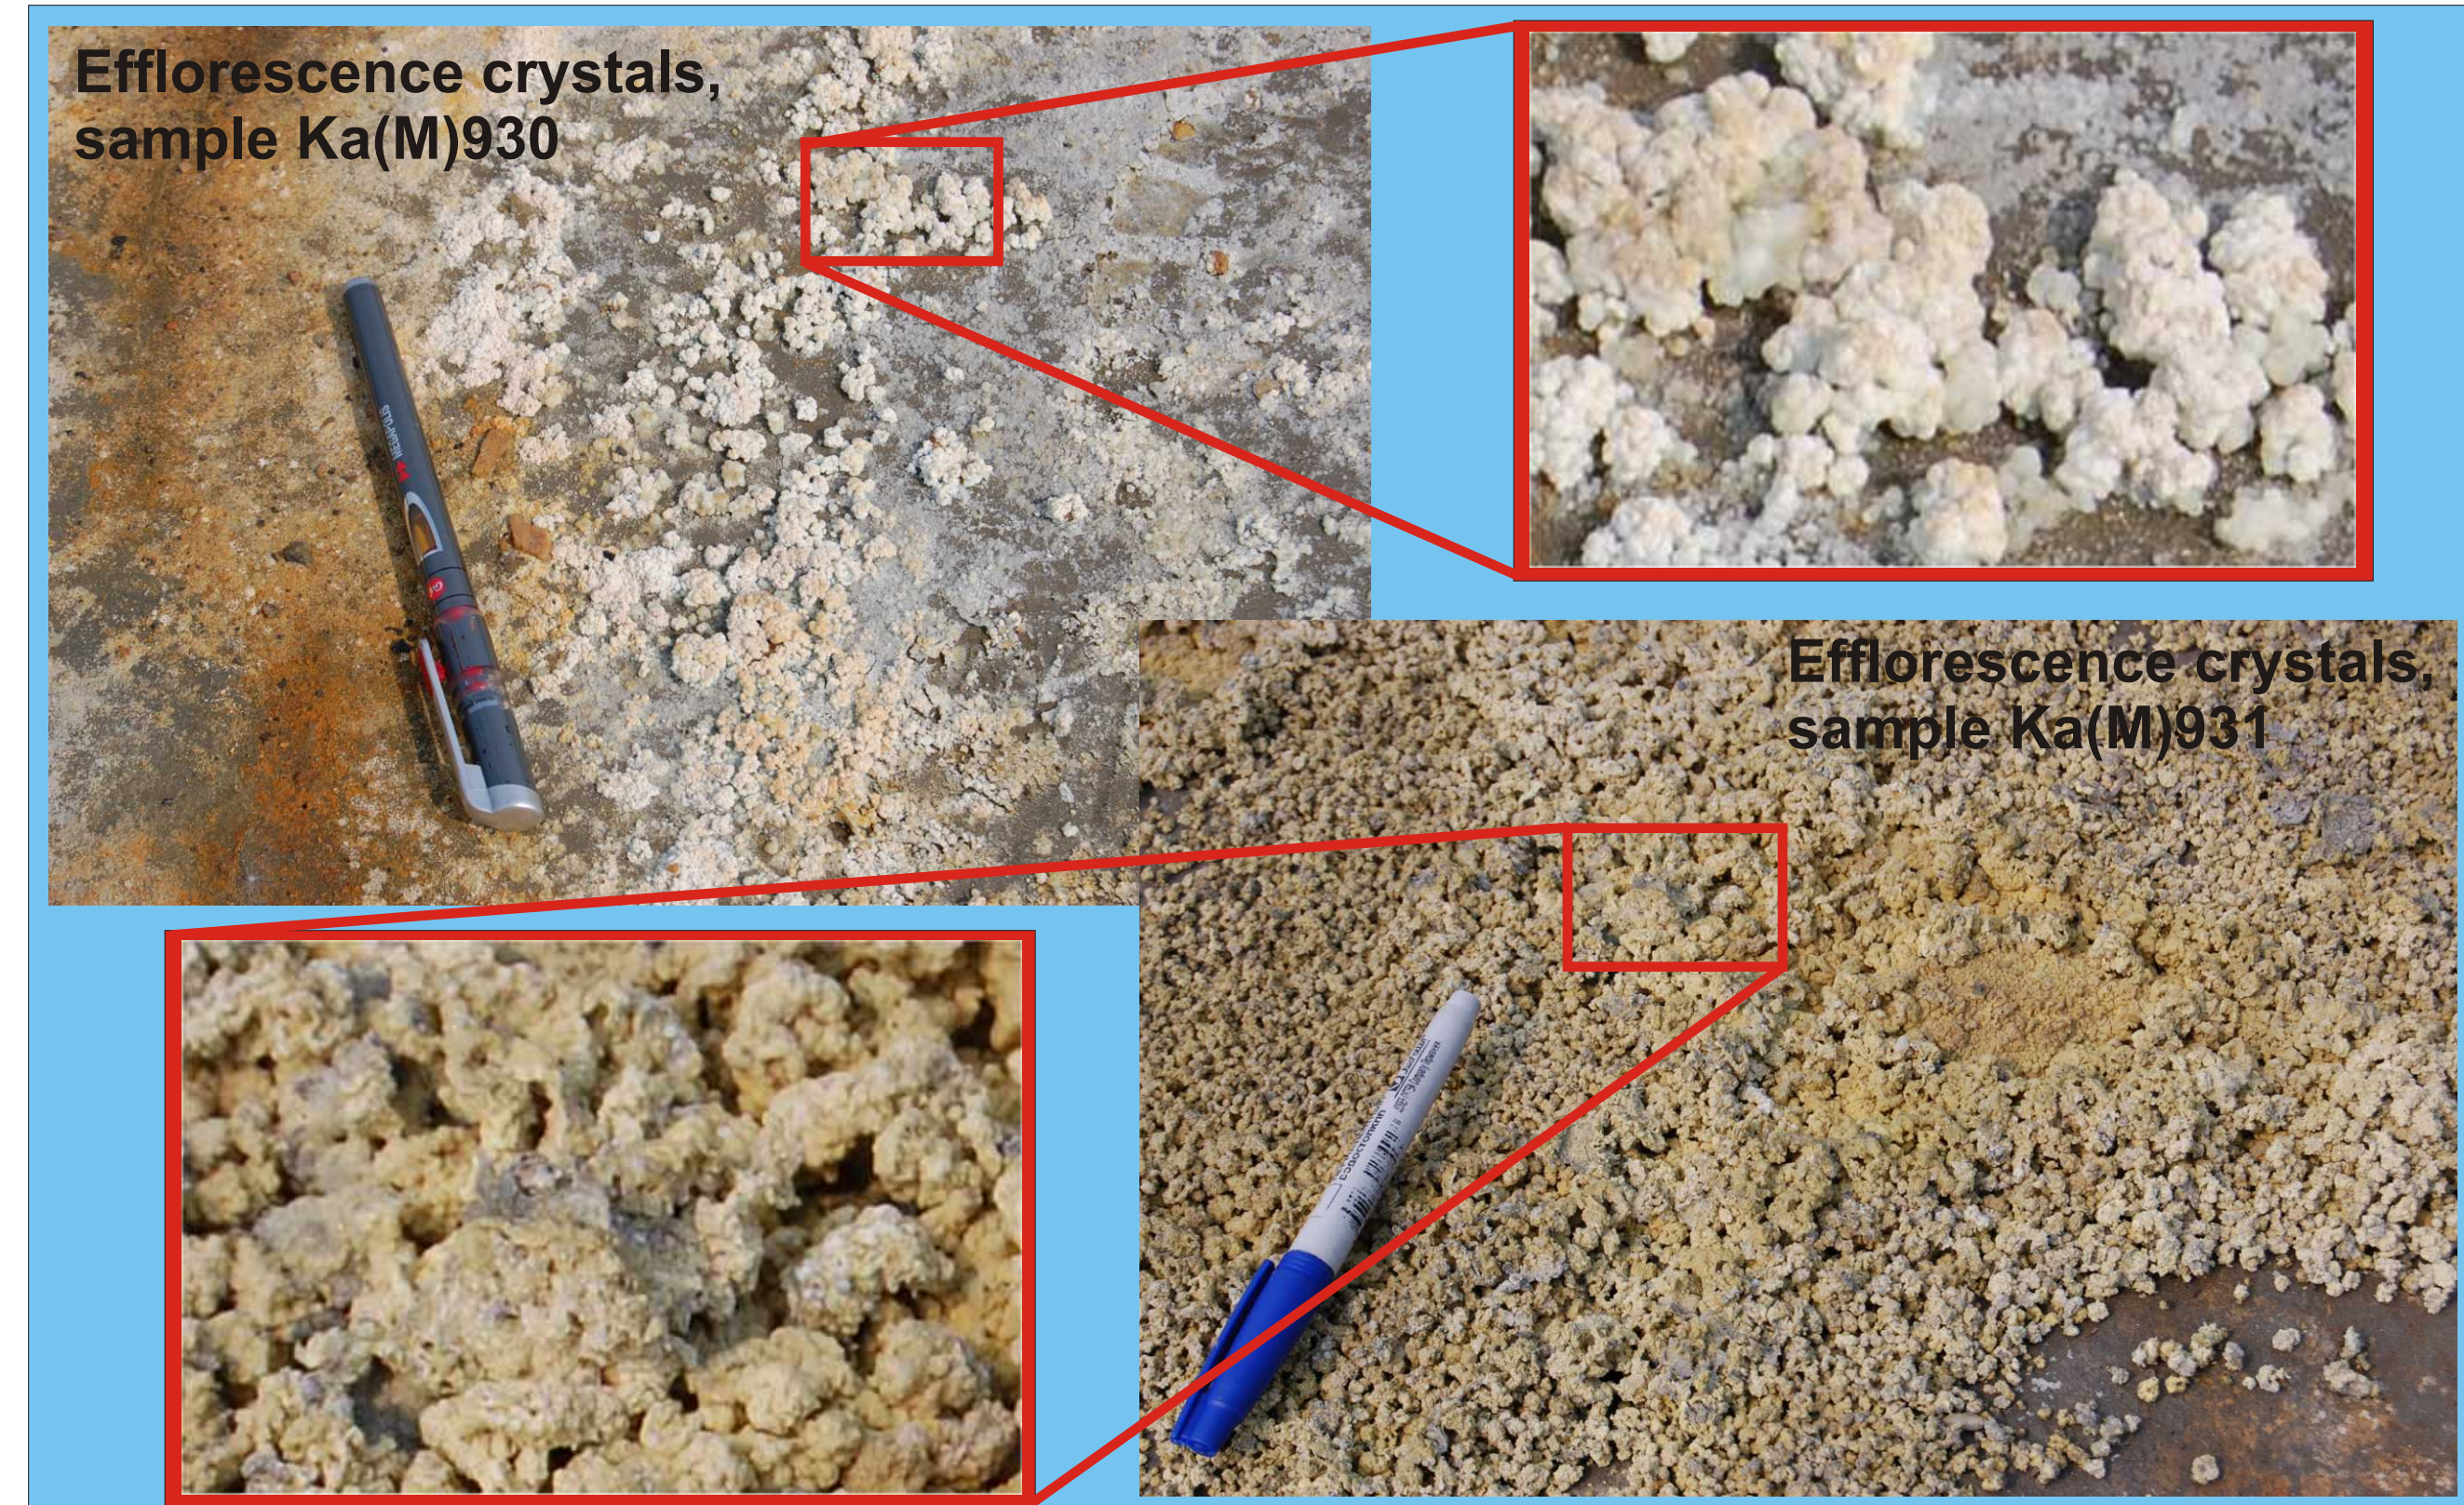
Efflorescence Crystals

Efflorescence crystals collected from the top of a mine tailings area, near the outwash stream from below a large tailings impoundment.

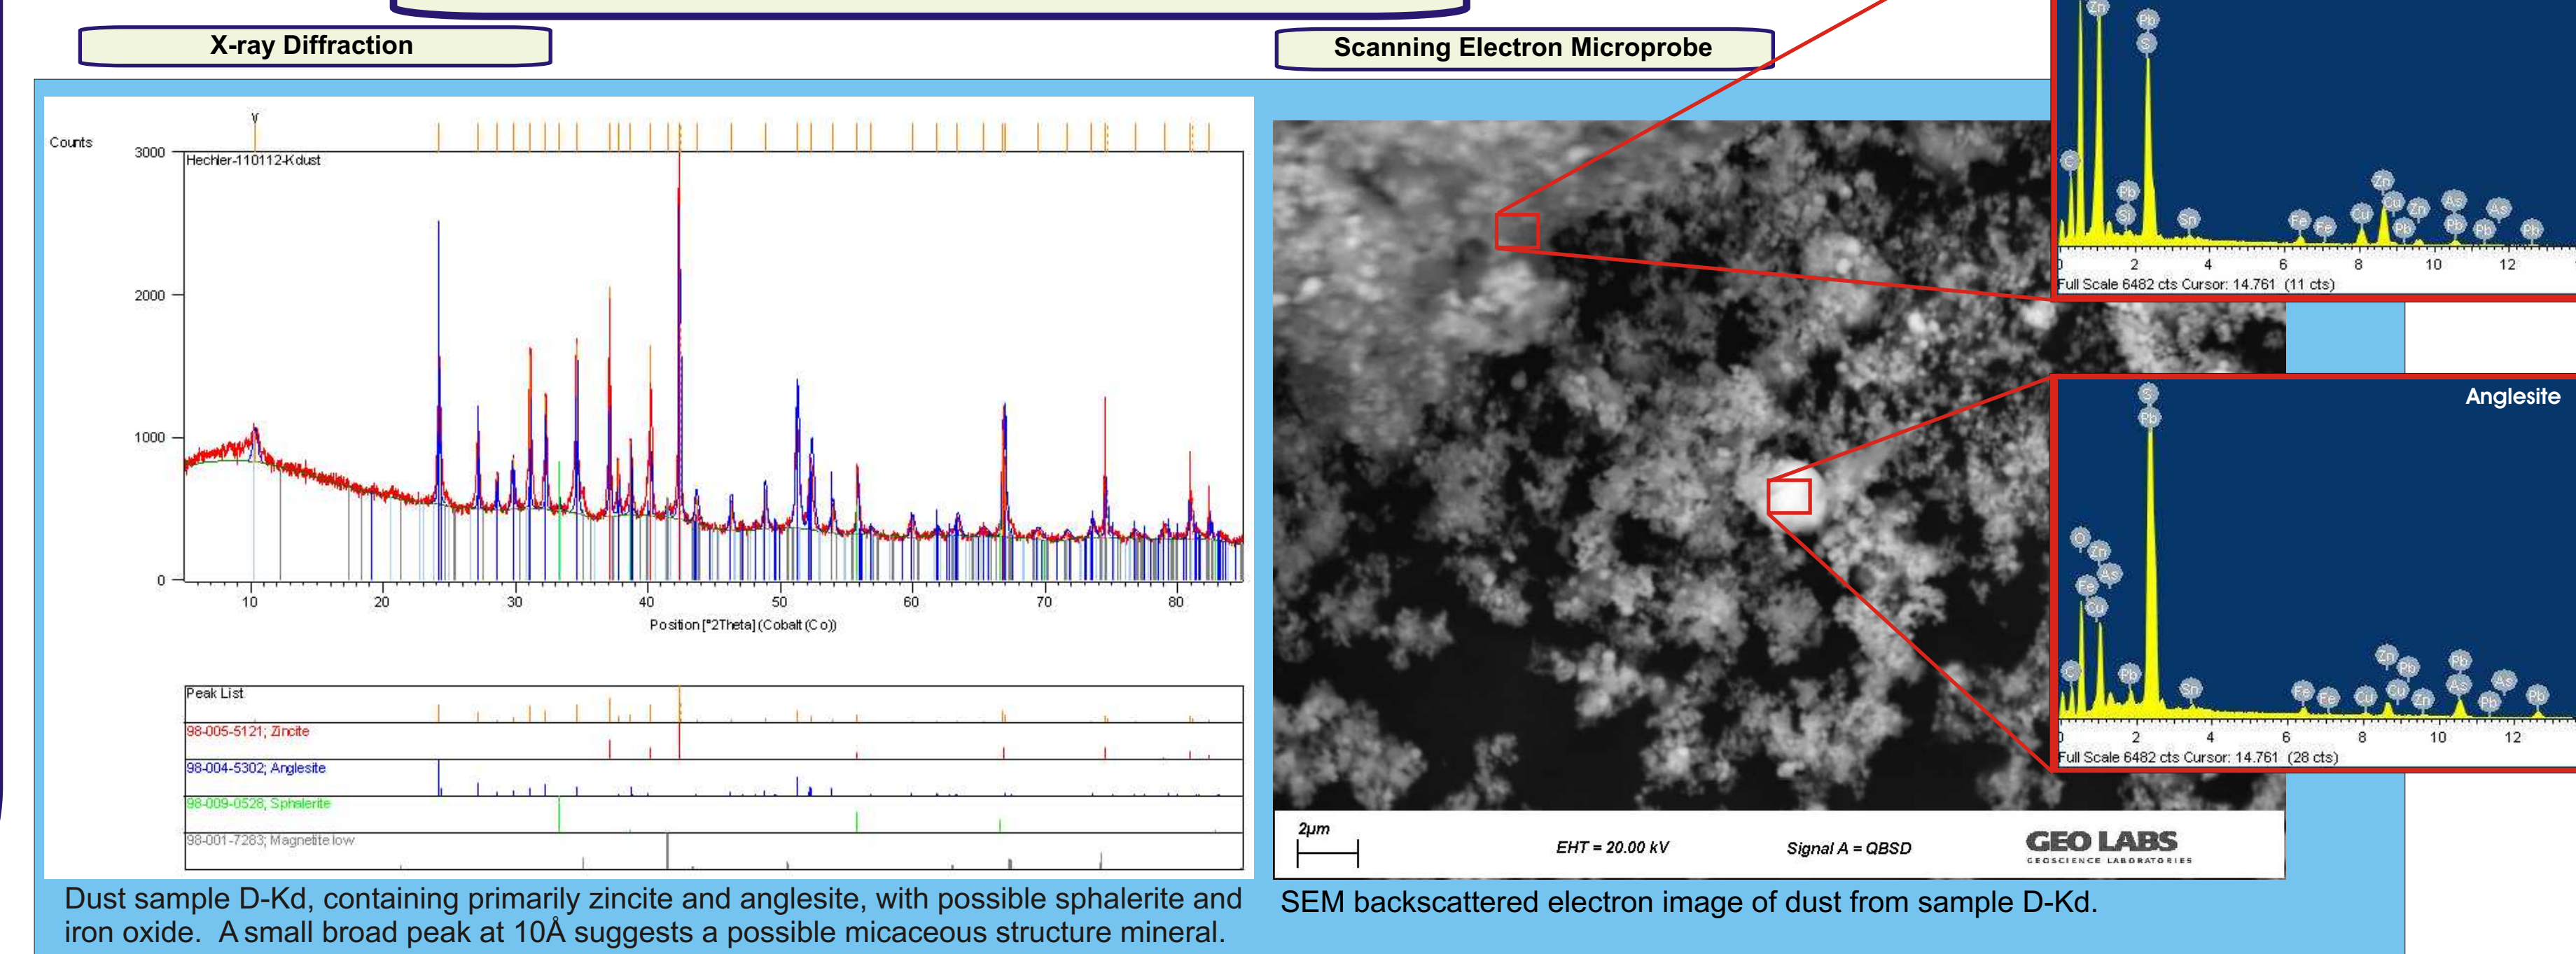
Smelter Emission Dusts

A smelter emission dust sample a few km from the smelter.
1. D-Kd Karabash
